National Transportation Safety Committee

Final Report

Garuda Indonesia Flight GA 152

Airbus A300-B4

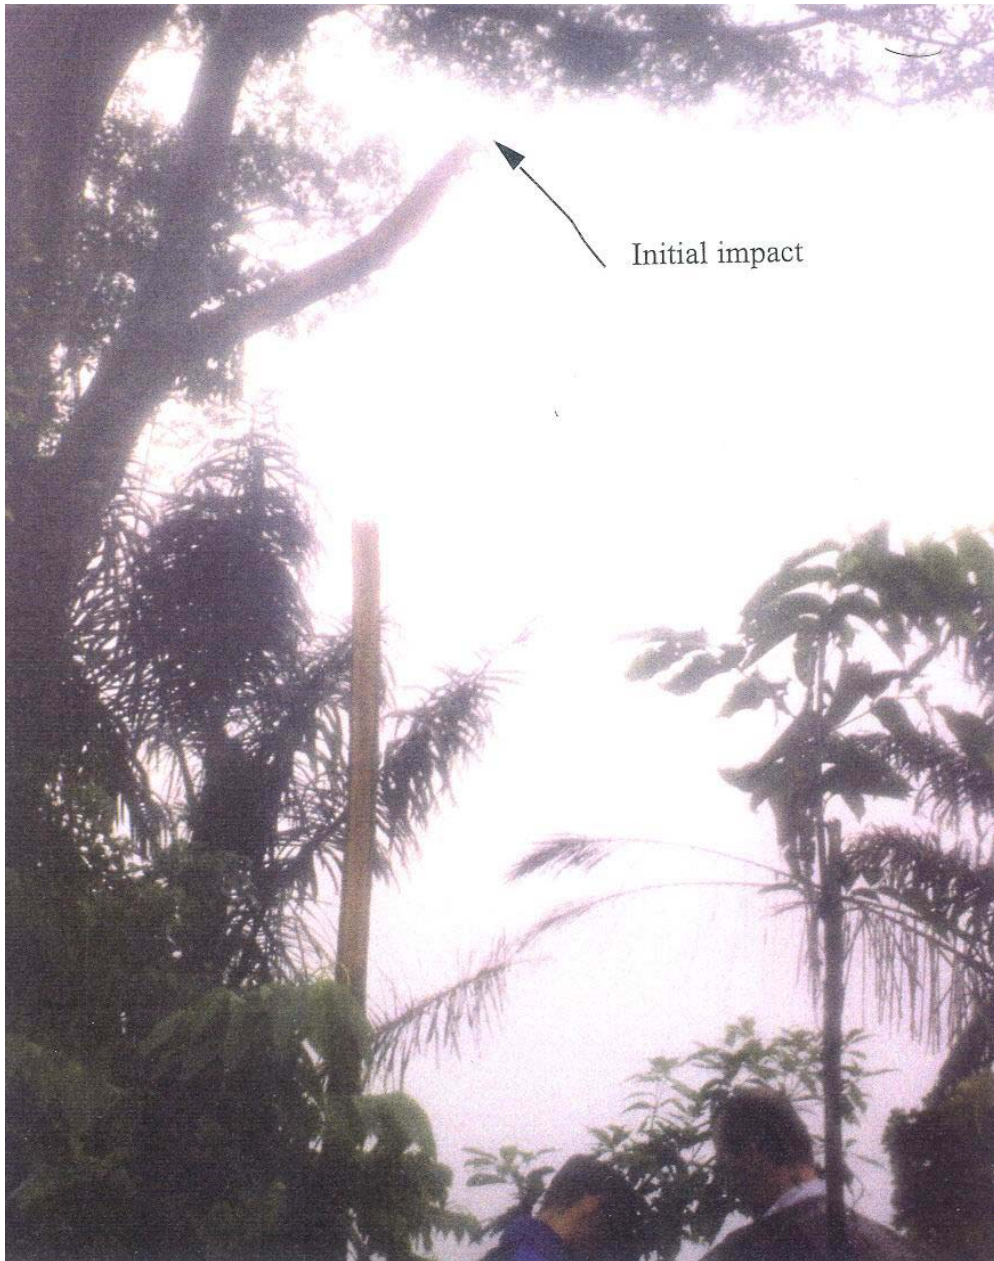
The initial impact with the tree on a ridge broke the tree trunk, approximately 1.5 to 2 meters from the top as indicated by the broken off tree trunk and branches found nearby. Foliages of the nearby trees along the approximate ground track and the immediate surroundings of the impact area were discolored by the fuel spill from the ruptured RH wing tank.

Figure 10. Initial impact tree, looking 060° M

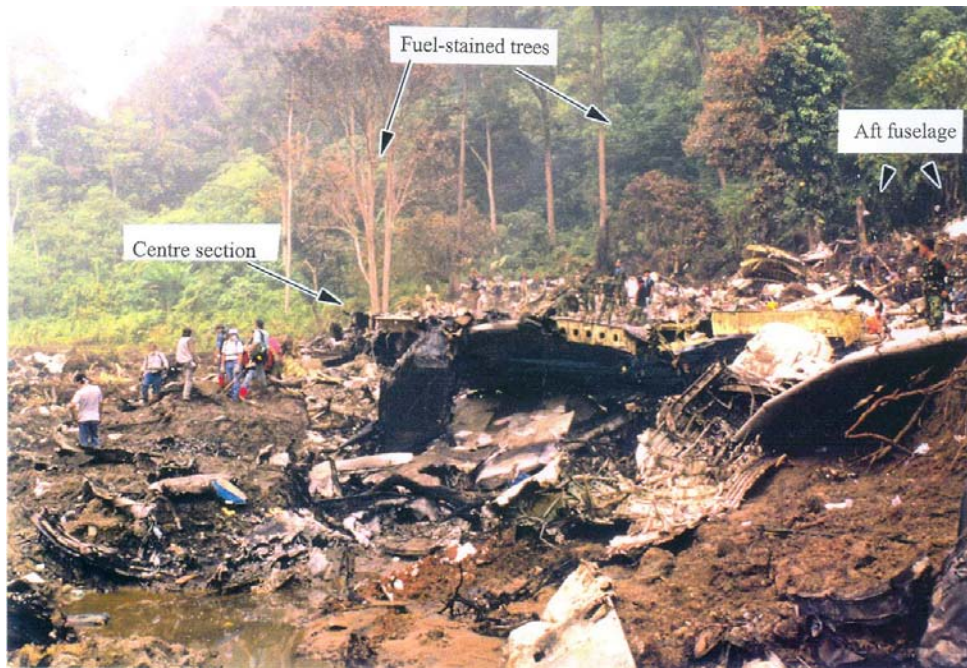
Figure 11. Main crash site, looking 235° M

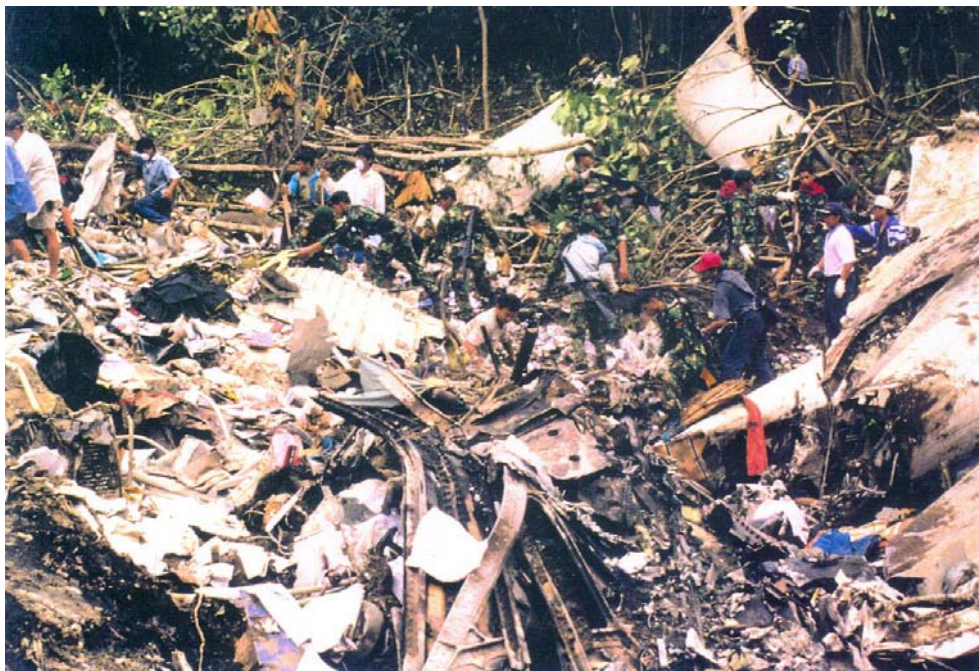
The aft fuselage including the stabilizers were found relatively intact and separated from the main fuselage, the latter being unrecognizable. Both horizontal stabilizer sections were completed, as were the fin (vertical stabilizer) and rudder sections. The fin was still attached at its lower end to portions of its upper fuselage frames.

Figure 12. Main crash site- aft fuselage and empennage

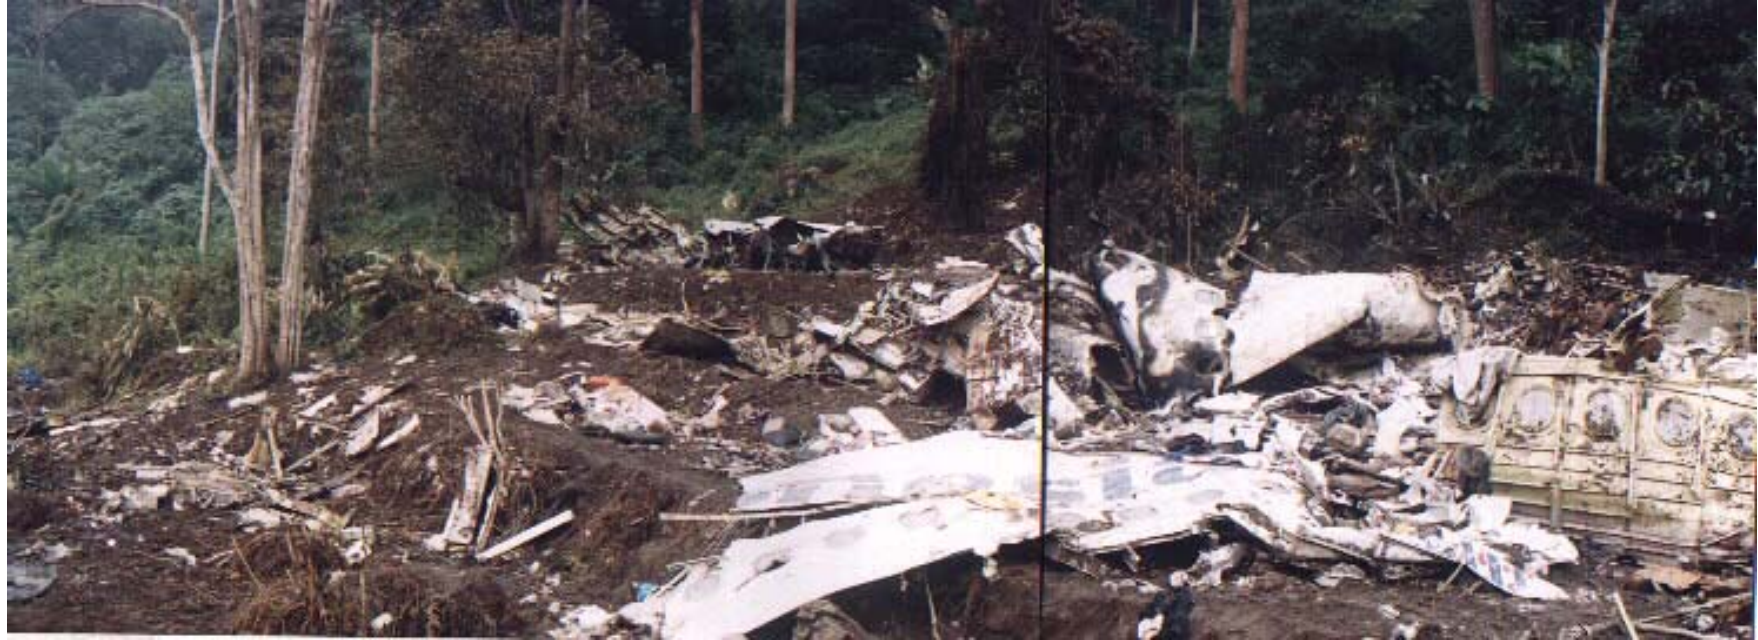
Figure 13. Crash site (1), an area of abandoned rice paddy terraces

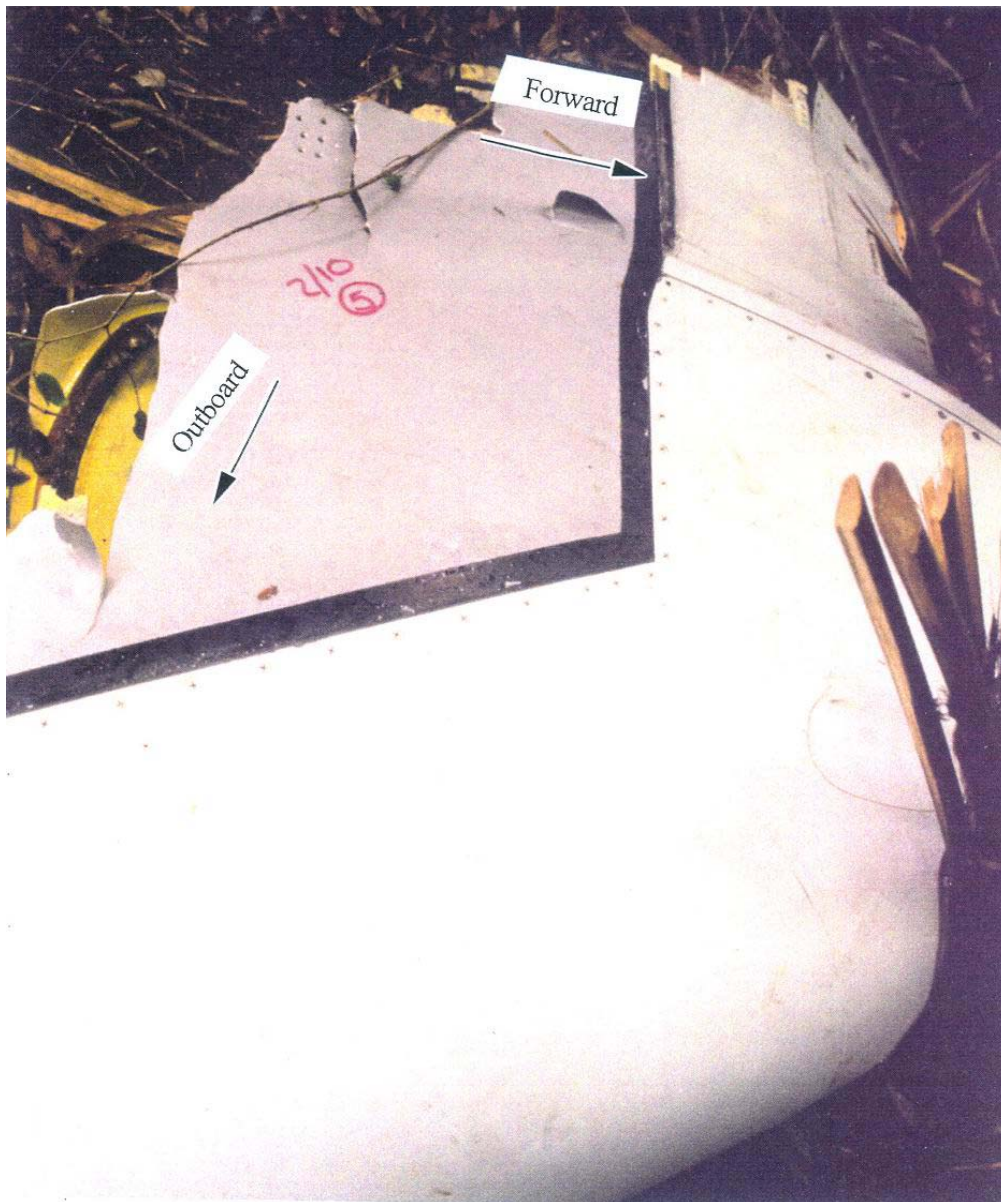
Figure 16. RH wing tip fairing and LE structure

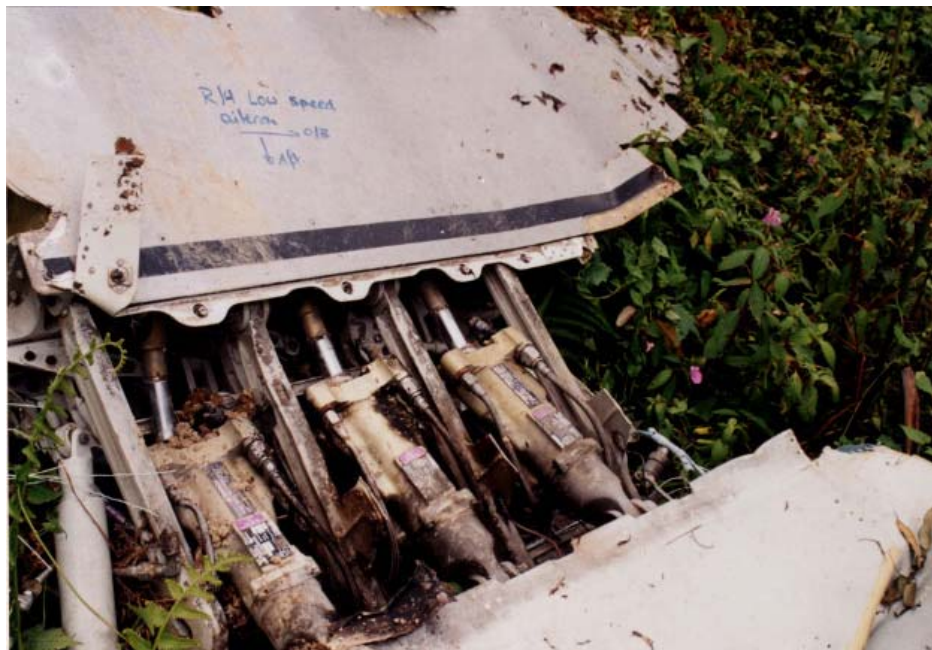
Figure 18. RH low-speed aileron

The outer portion of the RH wing had fragmented with the major wreckage extending only to the inboard end of the RH low-speed aileron. The inboard portion of this RH low-speed aileron (Figure 18) and section of wing was found in the trees on the RH side of the wreckage trail. The outboard portion of the RH low-speed aileron and the RH wing tip RH was found on the ridge, near the initial impact tree.

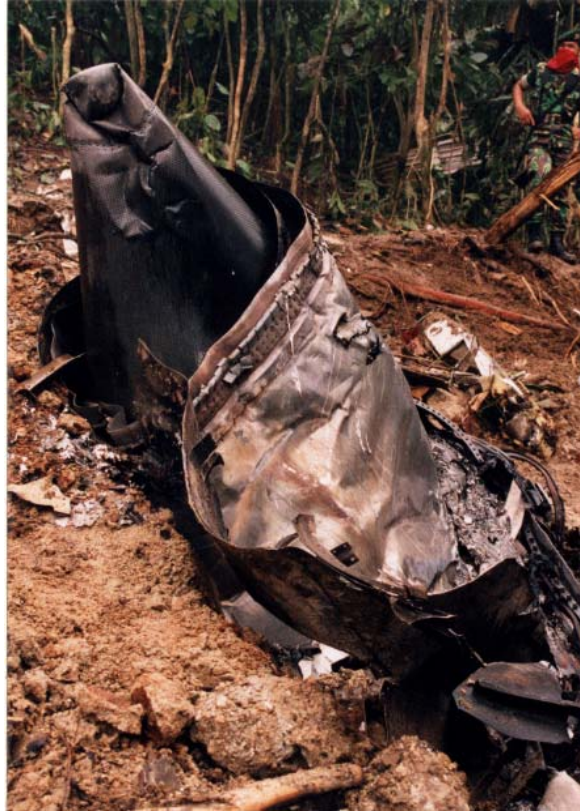
The engines were found in one piece. One of the two Pratt & Whitney JT9D engines was easily identified (Figure 19) nose down in mud close to the major impact tree and in the area of the left wing. The other engine was found, buried, close to the wing center section (Figure 20) and in a position entirely consistent with its being wrenched from the No 2 engine pylon, failing the pylon in the direction of the center section. The wing had moved further 9 meters side wards after the separation of this engine. Neither engine could be positively identified from serial number. However, at the base of the major impact tree at the crash site and FCU (fuel control unit) was found from one of the engines. This FCU's position was only consistent with its separation from the engine found some 10 meters away and engine record confirmed that the FCU serial number (s/n 96168) matched the No 1 (LH) engine.

Figure 19. LH P&W JT9D engine, nose down

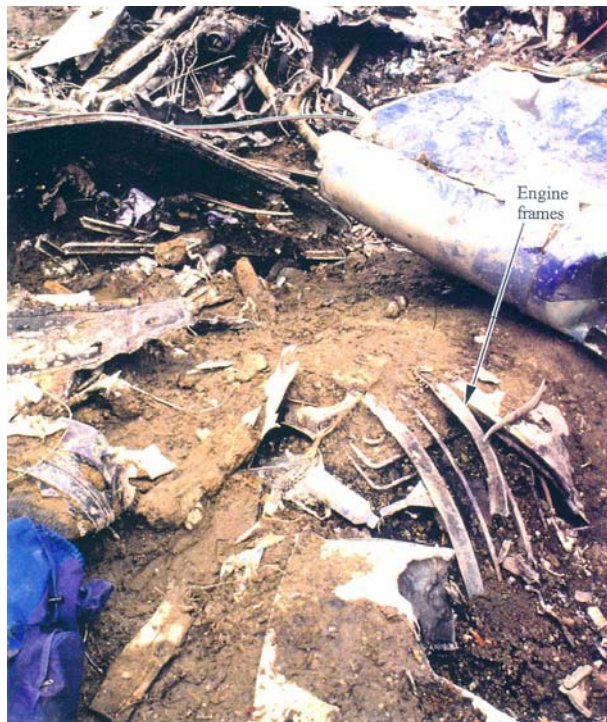
Figure 20. RH P&W JT9D engine, buried

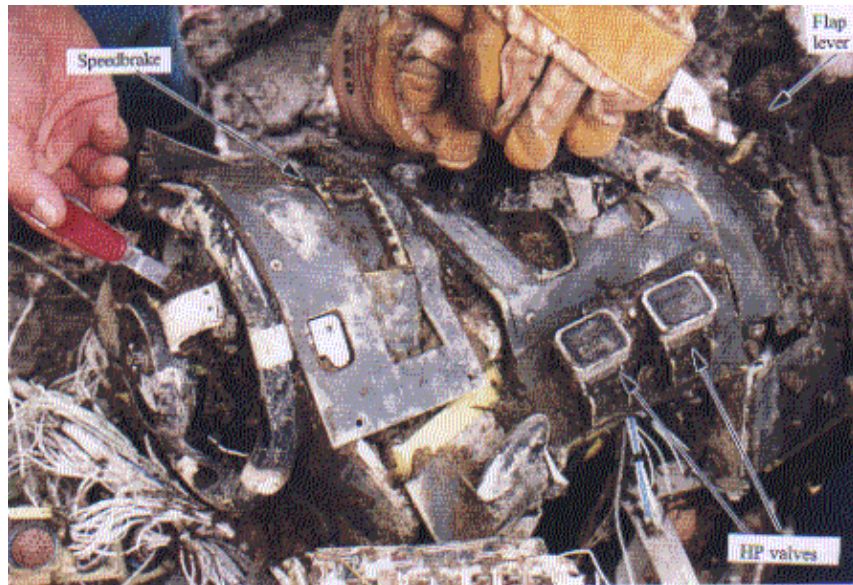
Figure 21. Part of central pedestal

The speed brake lever was found selected at mid range position on the ground with its handle bar broken. Extensive experience showed that the position of the speed brake lever as found during other accidents was good evidence of its position at impact. In the

The gated teeth of the speed brake mechanism and the pin were in relatively good condition. However, further examination during the teardown found that the speed brake lever could have been moved during impact. Therefore, the position of the speed brake handle cannot be used as a reference.

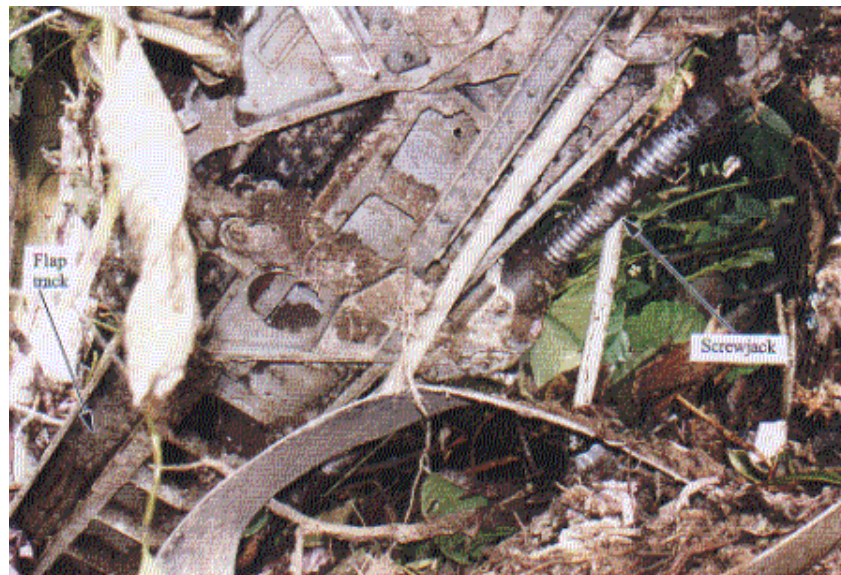
Despite the massive impact and fire damage, the majority of the flap and slat actuators were identified at the accident site. These actuators were of the 'screw-jack' type and are generally reliable as last position indication. Both flap actuators were in an intermediate position and the Airbus advisor confirmed that the screw-jacks corresponded to the 'flaps 8 and slats 16' positions. Figure 22 shows one of the flap screw-jacks with the nut and flap carriage showing the flap's intermediate position.

Figure 22. Flap screwjack and flap carriage
